Project Profile - Citrus County Landfill Expansion

The Citrus County Landfill in Lecanto, FL needed to create more airspace by constructing an expansion to the North end of the landfill. The project included an Expansion (Cell 3) to the Citrus County Central Landfill, which already had 2 cells filled and closing. This work would consist of Earthwork (Removing unsuitable soil and replacing with suitable), installation of eight different types of geosynthetics, installation of a Leachate Collection and Leachate Detection System, installation of a protective cover soil layer, and installation of a new access road with sod around the cell.

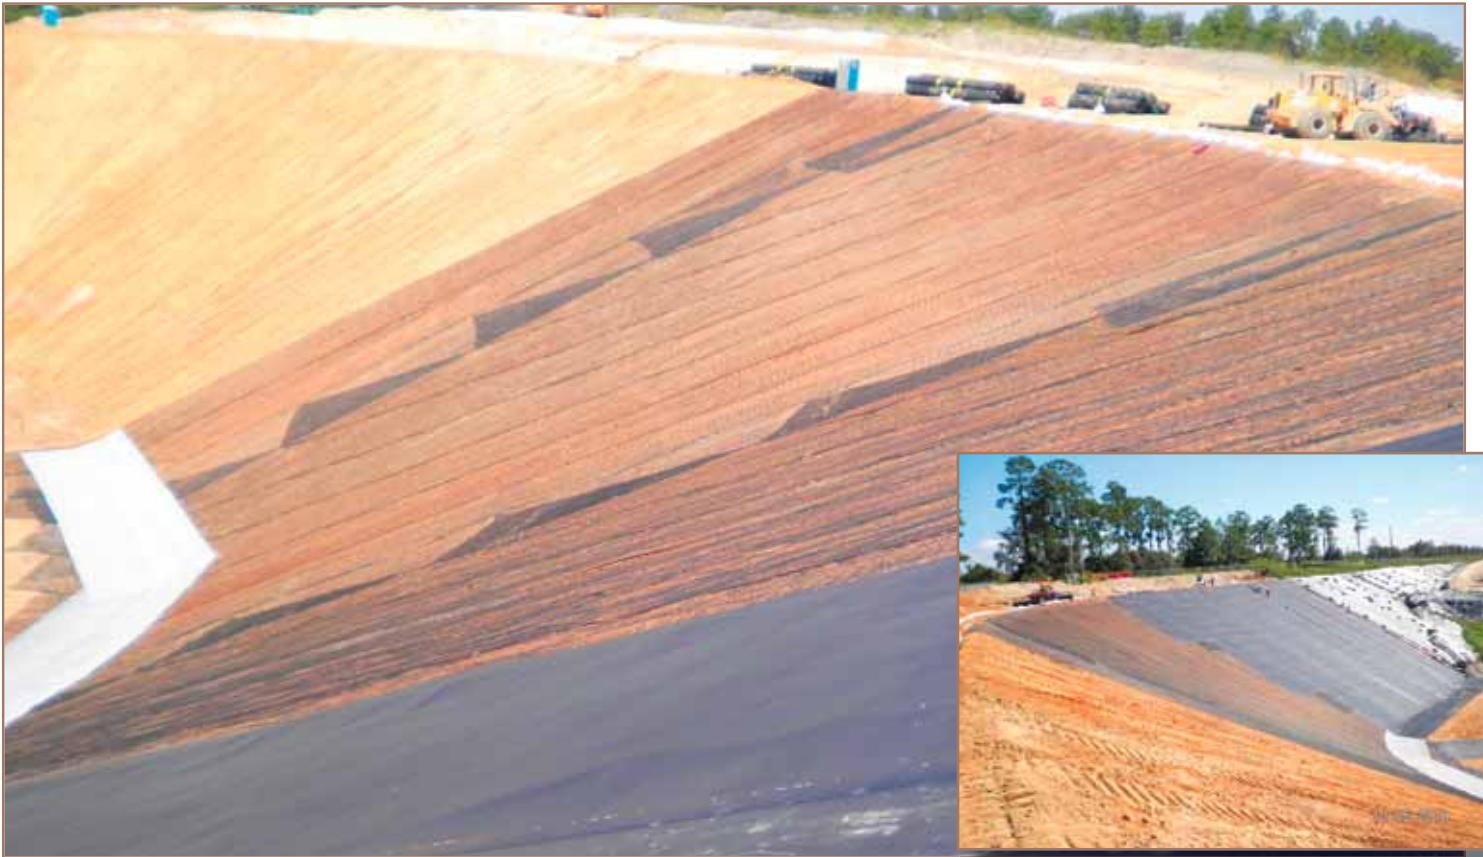
First panels of Biaxial Geogrid, GCL, and Geomembrane deployed at the East Side of the Citrus County Central Landfill Cell 3 Expansion Project.

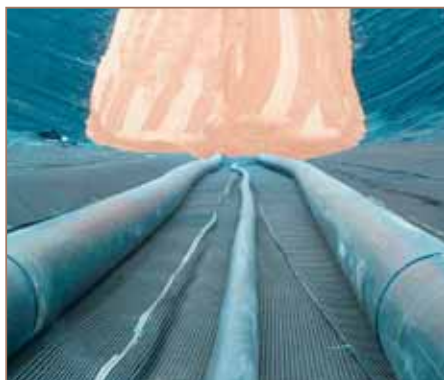
Leachate Collection System pipes sitting on top of panels of Uniaxial Geogrid at the West Side of the Cell.

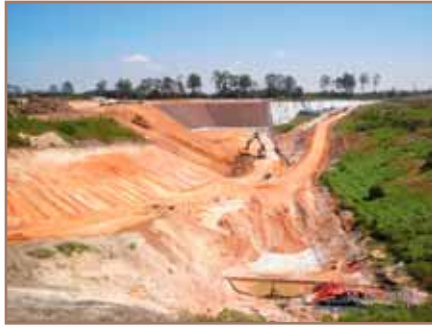
It took 3 months of stripping, excavating, and grading on the Cell before geosynthetics were ready for deployment.
